**Second  
International Conference  
on  
Case Histories in  
Geotechnical Engineering**

**June 1-5, 1988**

**University of Missouri-Rolla  
Rolla, Missouri**

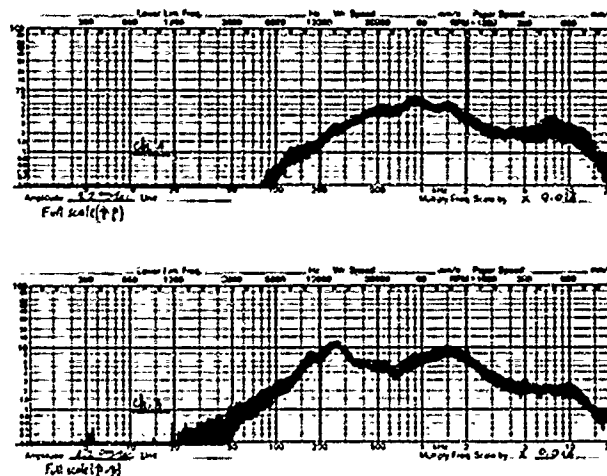
Fig. 11 - Velocity spectrum (third octave), Test 14, channels 1 and 3: driving of closest pile at 30m deep.

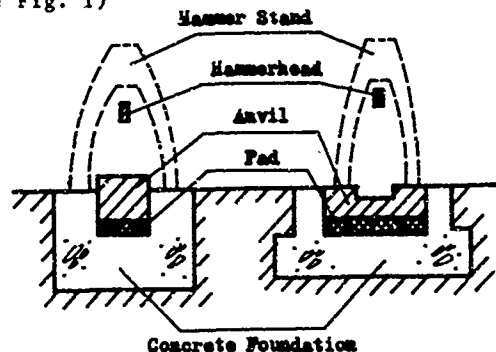
Fig. 1 Schematic of Free Forging and Die Forging

A hammer foundation mainly consists of falling part of hammer, hammer stand, anvil and foundation. The anvil and foundation are separated by a pad. All of the dynamic foundations, the hammer foundation is characterized by free vibration which is different from the others. This free vibration is an instantaneous vibration with damping. The instantaneous vibration is caused by two sources. One is an impulse, i.e. the action occurs at the instant when the falling hammer impacts the anvil. The other is a suddenly applied force, i.e. the force occurs as the impulse disappears. When the falling hammer is raising, the suddenly applied force disappears immediately, and then the impulsive force is formed. In general, the impulsive force is neglected, but the dynamic influence of the impulse is only con-

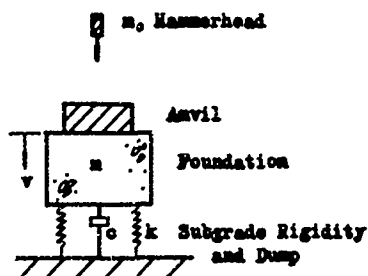
Fig. 2 Calculation Model for One-Degree-Freedom

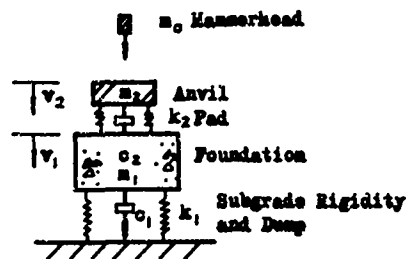
Fig. 3 Calculation Model for Two-Degree-Freedom

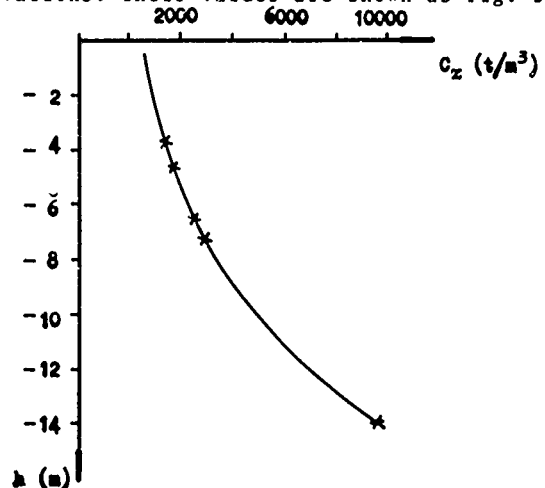
Fig. 5 Relationship between Cz and Depth

The trial pit was dug to a predetermined elevation (elevation of the hammer base). Concrete test block of square sizing 1.5X1.5X1 m<sup>3</sup> and round sizing d=0.845 m, h=1 m are placed into the pit respectively. Then, impact and forced vibration are applied onto them to get compression rigidity coefficient of subgrade of different hammer with different tonnages at different elevations. Their values are shown as Fig. 5.

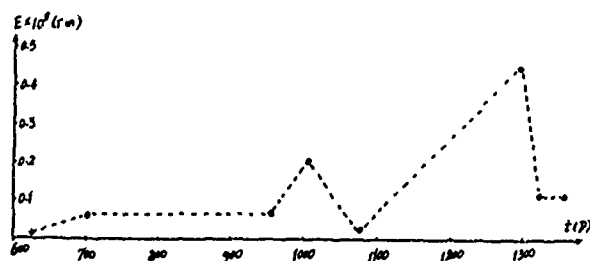
Fig.1 Energy-Time Relationship

When the forward surface reaches the depth of 6000 metres in 623<sup>th</sup> day, several rockmass elements in zone of fault begins to break, which sends out the energy of  $0.3186 \times 10^8$  t.m that equals to the earthquake magnitude of 4.1; With the underground water infiltrating furtherly, great readjustation of stress field takes place and the energy of  $0.6109 \times 10^8$  t.m. will be send out, which is equivalent to the earthquake magnitude of 4.2; When the forward surface reaches the depth of 9600 meters, the minor mainearthquake takes place., which sends out the energy of  $2.0868 \times 10^8$  t.m that is equicalent to the earthquake magnitude of 5; From this time, the stress field and infiltration field readjusts continuously and small earthquakes takes place frequently; The mainearthquake will take place in about 1300<sup>th</sup> day, the magnitude of which is 5.1. Fig.1 express the relationship between the energy and the time, the controlling point of which means the total energy sent out by all broken element in a period of time. Fig.2 shows the relationship between the earthquake magnitude and the time, which is corresponding to Fig.1. Because of the disconcentration of broken elements, the line connected through the controlling points may be regard as the maximum value line of earthquake sequence the energy sent out in any time will not surpass.

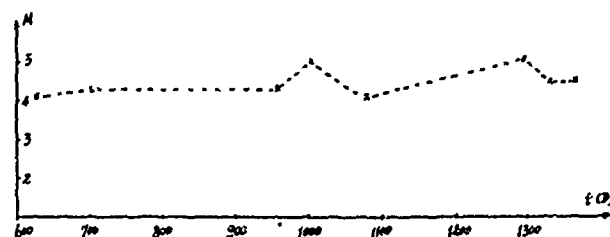
Fig.2 Earthquake Magnitude-Time Relationship

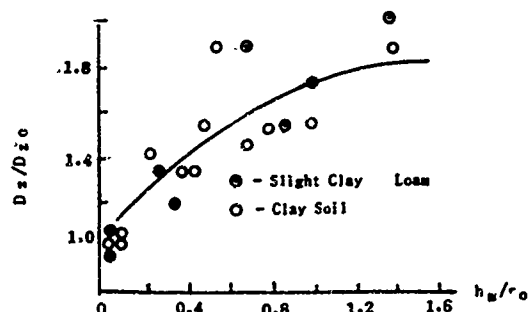
Fig.2 The Relationship between Relative Damping Ratio and Embedded Ratio of Foundation

In Fig.2 the parameters  $D_z$  and  $D_{z0}$  represent damping ratio corresponding to embedded depths  $h_m$  and zero respectively.

been established yet. The relationship of magnitude between  $D_z$  and  $h_m$  is shown in Fig.2 and expression 17. To clarify the effect of embedded depth of foundation on damping ratio 16 test foundations were built on clay loam and slight clay loam by the author and his colleagues.

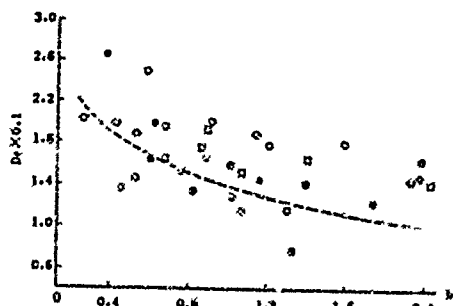
Fig.4 The Relationship between Damping Ratio and Value b under Different Soils

- Clay Soil
- Gravel Sand
- Clay Loam
- Medium Sand
- Loessial Clay Loam
- Residual Soil

The author altogether analysed 38 test data under various bases with Poisson's ratio ranging from 0.32 to 0.4 and shear modulus of elasticity from 39.2 Mpa to 176.4 Mpa. All of the test results are described in Fig.4.

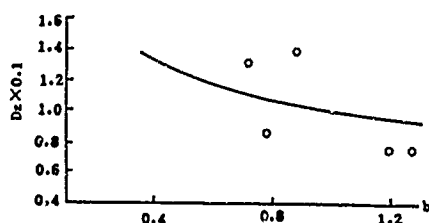
Fig.5 The Relationship between Slight Clay Loam and Value b

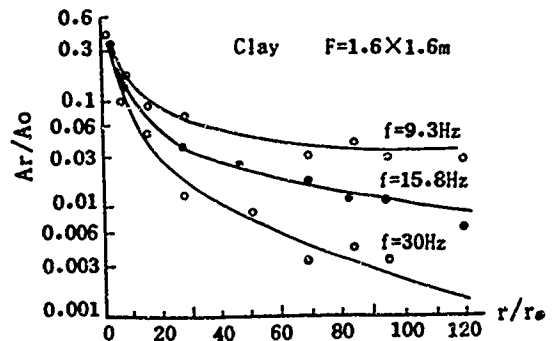
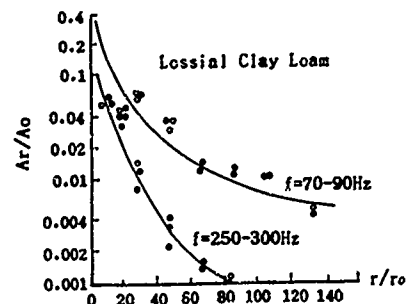
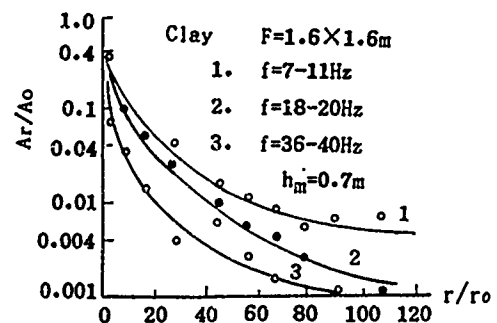
a) Attenuation of Vertical Wave under Vertical Vibration Source

b) Attenuation Law of High Exciting Frequency

c) Attenuation of Horizontal Wave under Horizontal Vibration Source

Fig.1 Effect of Frequency of Vibration Source on Propagation of Wave

Owing to the influence of frequencies of vibration source is not taken into account by the formula 1, hence the computation results are often far from the measured results.

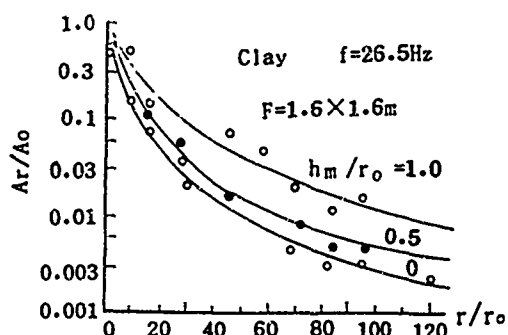
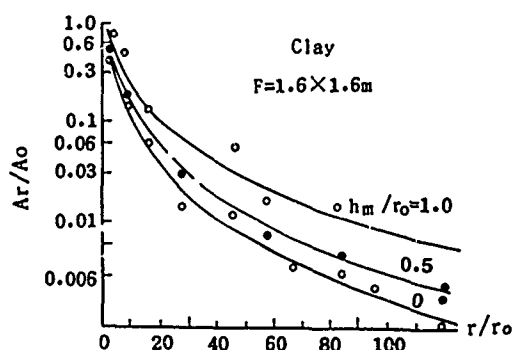
Fig.2 Effect of Embedded Depth of Vibration Source on Propagation of Wave

It shows from formula 2 that the attenuation of amplitudes of vibration with distances has only bearing on geometric parameter  $r/r_0$  and no bearing on embedded depth of foundations served as vibration source and other factors. However, the experiments show that the embedded depth of vibration source gives apparent influence to propagation of elastic wave. For instance, the figure 2a shows that at  $r/r_0 = 50$  and when  $h_m = 0, 0.5 r_0$  and  $1.0 r_0$  (  $h_m$  = embedded depth of foundation as vibration source ), then the measured relative amplitudes  $A_r/A_0$  equal 0.01, 0.018 and 0.40 respectively. Since the formula 2 does not consider the effect of embedded depth of vibration source on propagating wave and other factors, and then it makes the computation results do not coincide with measured results as shown in Table II.

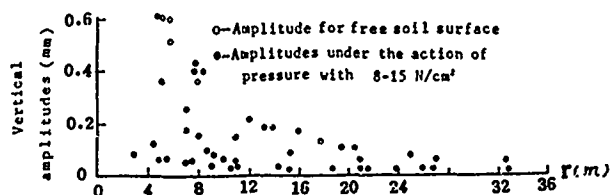
Fig.3 Effect of Pressure Acting on Soil Surface on Propagation of Wave

However, so far the effect of external pressure acting on the soil surface of wave receivers is scarcely researched. In order to clarify this problem a number of field tests is carried out by the authors. Experiments indicate that the amplitude under the action of pressure at wave receivers are much less than those of free soil surface as shown in Fig. 3.

For example, at  $r=16$  m the amplitude equals 0.07 mm for free soil surface and only equals 0.02 mm for existing of pressure which equals 12 N/cm<sup>2</sup>, while the total acting force corresponding to pressure equals 1080 kN. Meanwhile, it follows from Fig. 3 that the ratio of vibration amplitudes under the action of external pressure to the amplitudes under free soil surface is different. Generally speaking, the shorter the distance from vibration source, the smaller the ratio. However, the ratios are not less than 0.4 within the range tested. The test results as shown in Fig. 3 are obtained under the action of pressure which equals 8-15 N/cm<sup>2</sup>, and which is induced by industrial factory building with one story. In the case of other pressures the ratio of amplitudes of vibration shall generate variation to some extent.

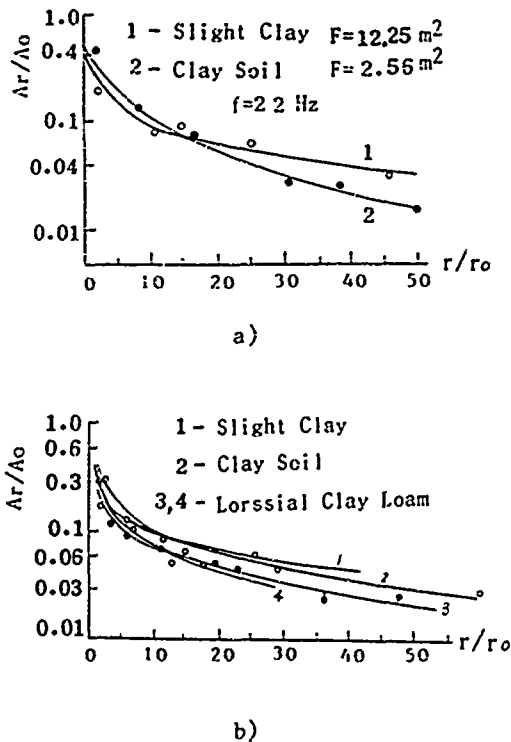
Fig.4 Effect of Different Soils on Propagation of Wave

According to the propagation theory of elastic wave in absolutely isotropic homogeneous elastic body the attenuation law of amplitudes of vibration should be different for soils. In the period of research the authors ever paid attention to the effect of soils on propagating of wave and did to try to consider this factor. However, the practice does not coincide with expectation of authors. For instance, the figure 4 shows that the attenuation law of vibration amplitudes is different only in a

small degree. Even, the inverse phenomenon is obtained in test results. For example, the attenuation of vibration amplitudes with distances for slight clay loam with smaller bearing capacity 15 N/cm² and smaller elasticity is more slow and moderate as compared with clay soil with larger bearing capacity 25 N/cm² and elasticity. The phenomenon like the kind of example above was ever introduced in literature [1], which points out that the coefficient of energy absorption for gray water-saturated sand with laminae of peat and organic silt equals 0.04 m⁻¹, while the coefficient for yellow water-saturated fine-grained sand with larger elasticity inversely equals 0.1 m⁻¹. On the ground of these cases we hold that the effect of soils on propagating of surface wave may be ignored to a first approximation under the soils tested. In this respect the treatment method of this paper is, in principle, is in agreement with the design code of machinery foundation (CHN II 19-79) of USSR.

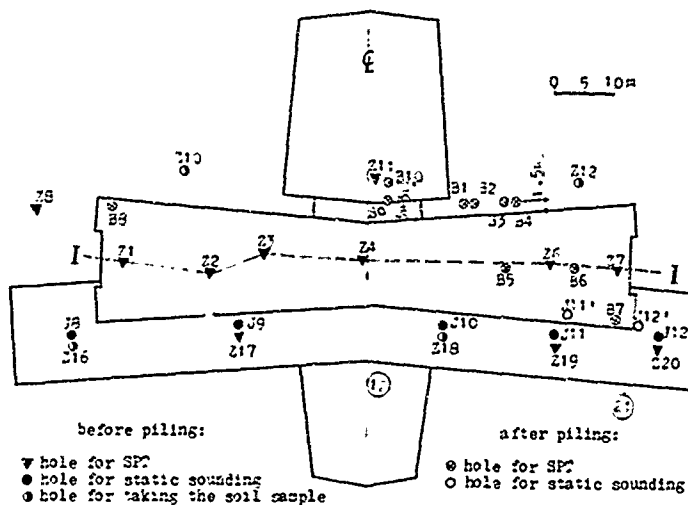
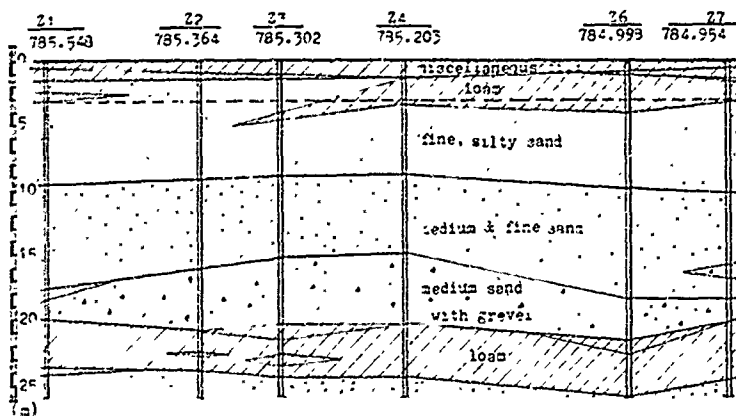
(a) Plan of bore holes and building

(b) Soil profile I-I

Fig. 1. Plan of bore holes and soil layer profile

The construction site is located on the terrace of Fenhe River in Taiyuan, the capital city of Shanxi Province. The design earthquake intensity is 8 degree of corrected Mercalli. The building is 18-storied with a rigid box foundation supported by 825 precast piles. Fig. 1 and Fig. 2 show the building's plan and its pile distribution. The liquefiable sandy layers involved silty-fine sand, fine-medium sand and sandy loam at -3.5~-14.5m depth (Fig.1b and Table I).

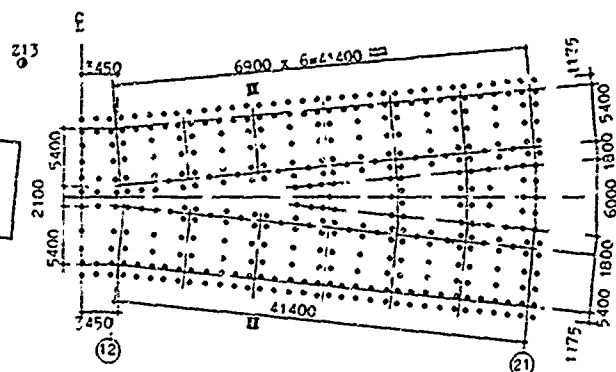
Fig. 2. Plan of pile distribution

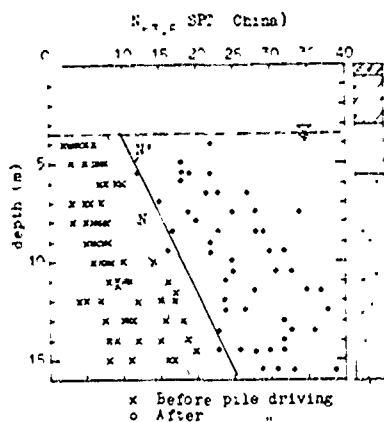
Fig. 5. Change of SPT values under whole area of pile foundation

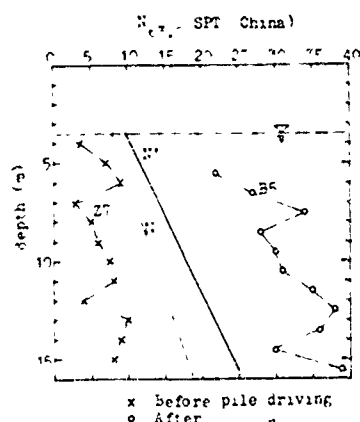
Fig. 6. Change of SPT values under the centre area of building

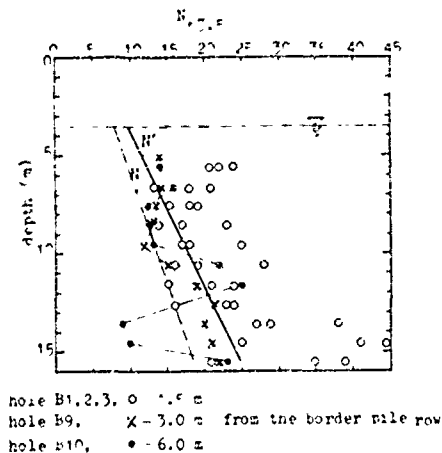
Fig. 7. SPT values for soils out of border pile row after driving

The SPT values are greater than the critical values at the distance 3.0m out of the border of foundation and the liquefiable layers have lost their liquefiable character. But at distance 6.0m from the boundary of foundation only the soil layers at -12~-14m depth remain liquefiable (Fig. 7).

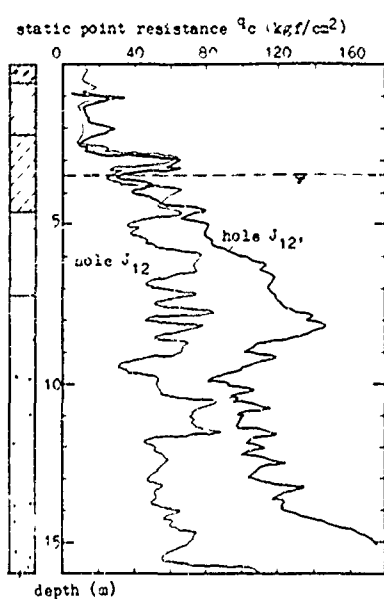
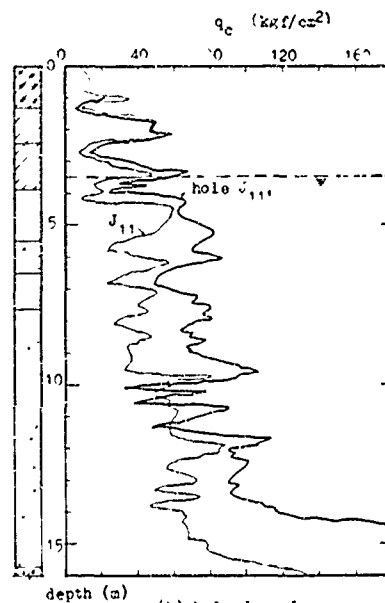
(a) hole J<sub>12</sub>, J<sub>12</sub>'

(b) hole J<sub>11</sub>, J<sub>11</sub>'

Fig. 8. Change of point resistance of CPT

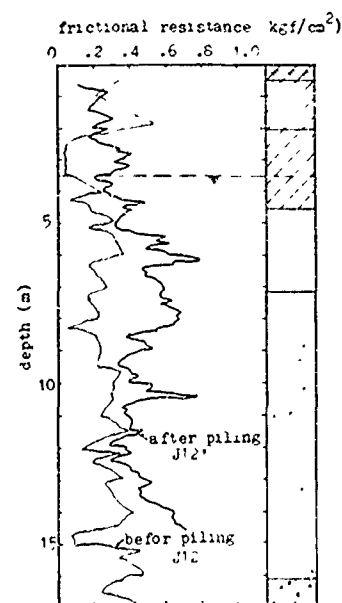
Fig. 9. Change of lateral friction of CPT

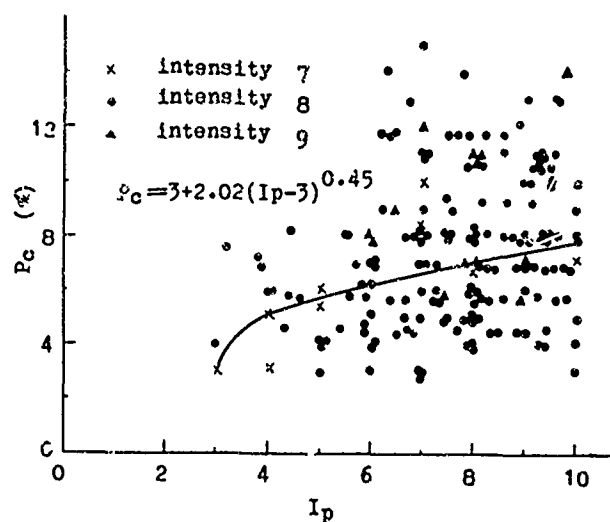
Fig.1 Plasticity Index  $I_p$  vs. Clay Content  $P_c$

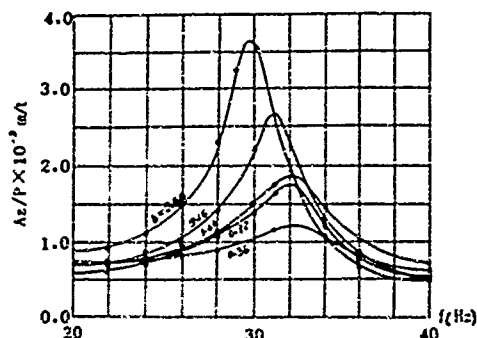
Fig.2 Amplitude-Frequency-Curve under Exposed Foundations and Vertical Vibration

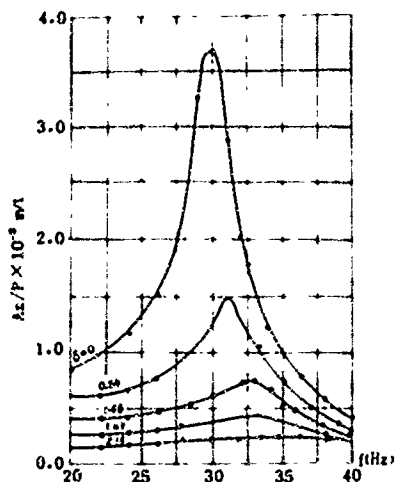
Fig.3 Amplitude-Frequency-Curve under Conditions of Embedded Foundation

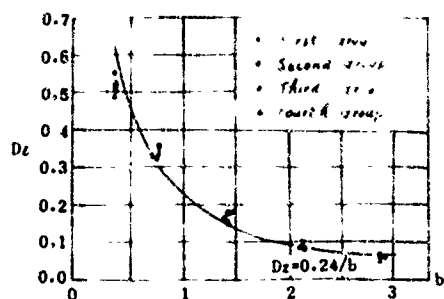
Fig.4 Relation between Vertical Damping Ratio and b under Exposed Foundation

The expression 10 is represented in Fig. 4 by solid line.

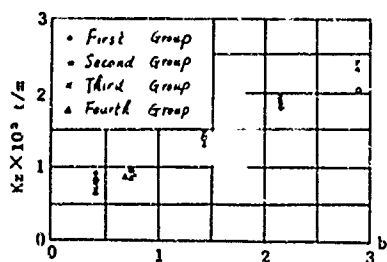
Fig.5 Relation between Vertical Rigidity and b under Exposed Foundation

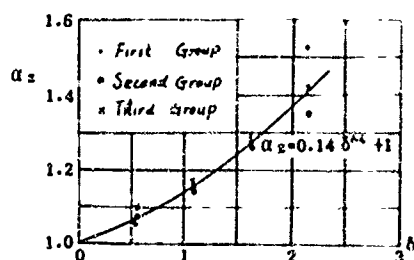
Fig.6 Relationship between Increasing Coefficient of Natural Frequency and Embedded Ratio of Foundation

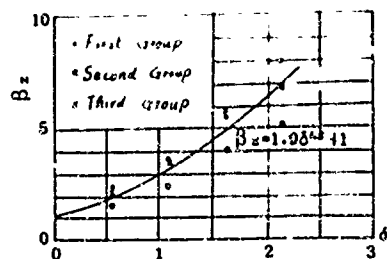
Fig.7 Varying Law of Increasing Coefficient of Vertical Damping Ratio with Parameter  $\delta$

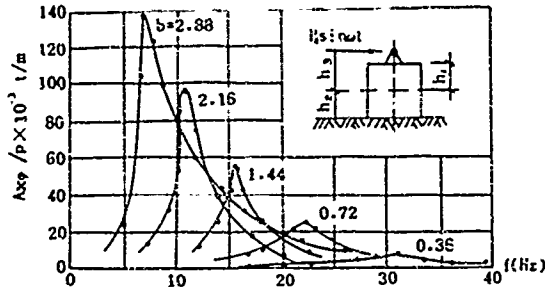
Fig.8 Horizontal Amplitude-Frequency-Curve under Different Value of  $b$

in H ), the Fig. 8 and Fig.9 are cited. The Fig.8 describes the relation of amplitude to mass ratio  $b$  and exciting frequency under the condition of  $h_m = 0$ . It follows from Fig.8 that the greater the mass ratio  $b$ , the larger the response of amplitude. The Fig.9 describes the relation of amplitude to embedded ratio  $\delta$  of foundations and exciting frequencies  $f$ . It is seen from this figure that the greater the embedded ratio  $\delta$ , the smaller the response of amplitude of vibration.

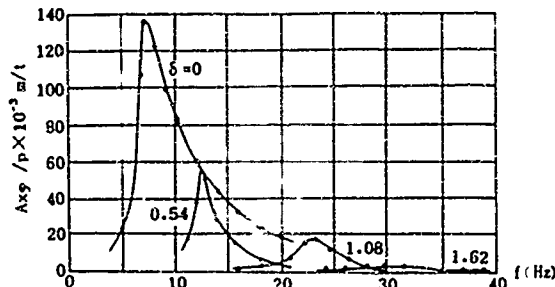
Fig.9 Horizontal Amplitude-Frequency-Curve under Different Value of  $\delta$

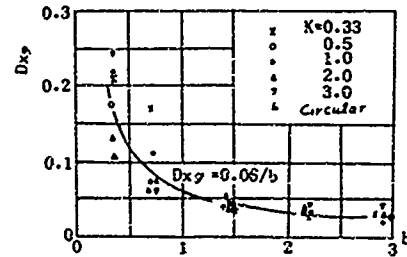
Fig.10 Relationship between Damping Ratio of Sliding-Rotation Vibration and Parameter  $b$  under Exposed Foundation

As for the variation of rigidity and damping with varying  $b$  under the condition of exposed foundations the Fig.10 and Fig.11 clearly describe it in detail.

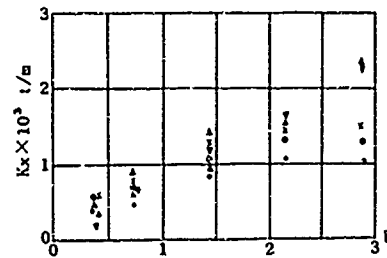
Fig.11 Relationship Between Horizontal Rigidity and Parameter  $b$

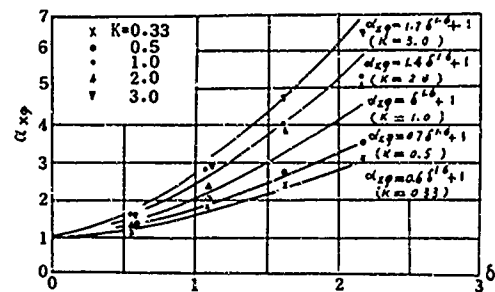
Fig.12 Variation of Increasing Coefficient of Natural Frequency with  $\delta$

These expressions are described in Fig.12 and Fig.13 in solid line.

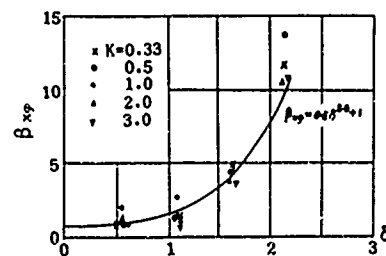
Fig.13 Variation of Increasing Coefficient of Damping Ratio with  $\delta$

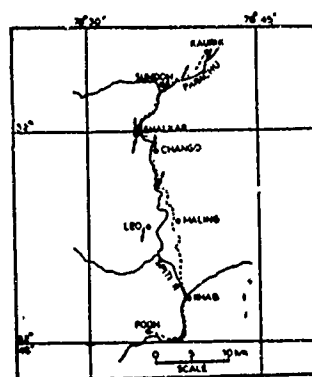
Fig. 2. General trend of ground fissures in area affected by 1975 Kinnaur earthquakes.

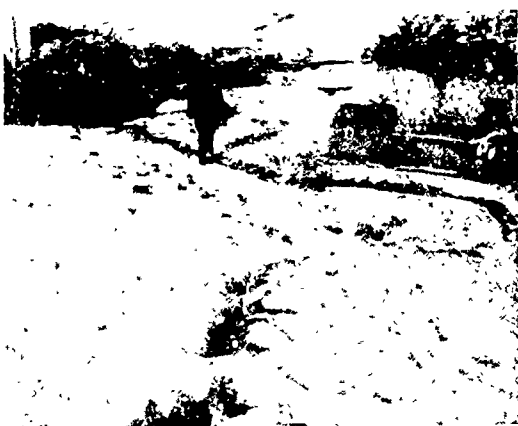
Fig. 6. En echelon ground fissures (partly covered by subsequent snowfall) near Kaurik village.

(Fig. 3 and 4). Extensive fissures were developed in the frozen ground in glacial moraines overlying bed rock. Figure 5 show fissures passing through Kaurik village which was completely destroyed, and individual fissures extended to 50 ft to 100 ft (15-30m) in length trending  $N 335^\circ$  to  $N 35^\circ$  (Fig. 6). Width of openings varied from fraction of an inch to several feet (few cms to a metre) with down throw towards west. A fracture zone with opening of 4 to 6 in (10-15 cm) with individual en echelon fractures could be traced over 1100 yards (1 km) extending from the edge of the terrace south of Kaurik village, towards hill slopes north of the village. Fissures in the ground transverse to the ridge covered with frozen glacial moraines with openings from a fraction of an inch to 6 in (15 cm) developed between Sumdoh and Kaurik with their general trend along  $N 25^\circ$ .

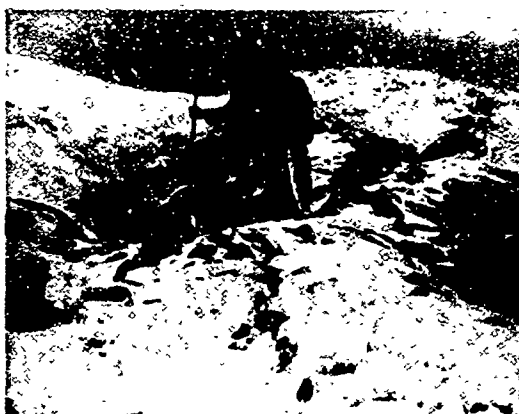
Fig. 12. Dislodging and overturning of boulders at the top of the ridge near Leo.

Overtuning and sliding of boulders and rock blocks at the top of ridges (Fig. 12) and steep slopes took place by development of tension cracks. Seismic stress waves incident at the frozen ground surface on reflection as tensional stress wave shriveled and blighted the frozen ground and rockmass. The resulting scabbing and slabbing of rock mass along joints, partings and other weak planes caused loosening, dilation and crumbling of hill sides, often with deafening sounds in heap of debris. The reflected tensile stress wave caused separation along discontinuity surfaces filled with frozen ice and weathered material, frozen-glacial maraines and fluvio glacial deposits forming flat terraces and mounds along the river valleys developed similar tension fractures resulting in dislodging, overturning and heaving up of large boulders (Fig. 13) and chunks of rock mass. Boulders at hill tops were reported to toss up and down. Fragments from steep rock slopes on rupture flew off with seismic (P-wave) velocity and hit telegraph poles (fig. 14), trees and roof tops and some of the flying fragments pierced through telegraph poles. Large dislodged boulders and chunks of rock at many places fell on road (Fig. 15) disrupting and damaging hillside and roadside houses (fig. 16).

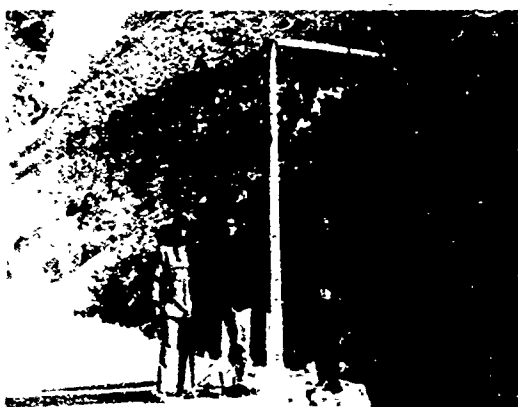
Fig. 16. Collapse of check post at Shalkar on India-Tibet road. Big boulder rolling down from hill slope caused collapse of the building.

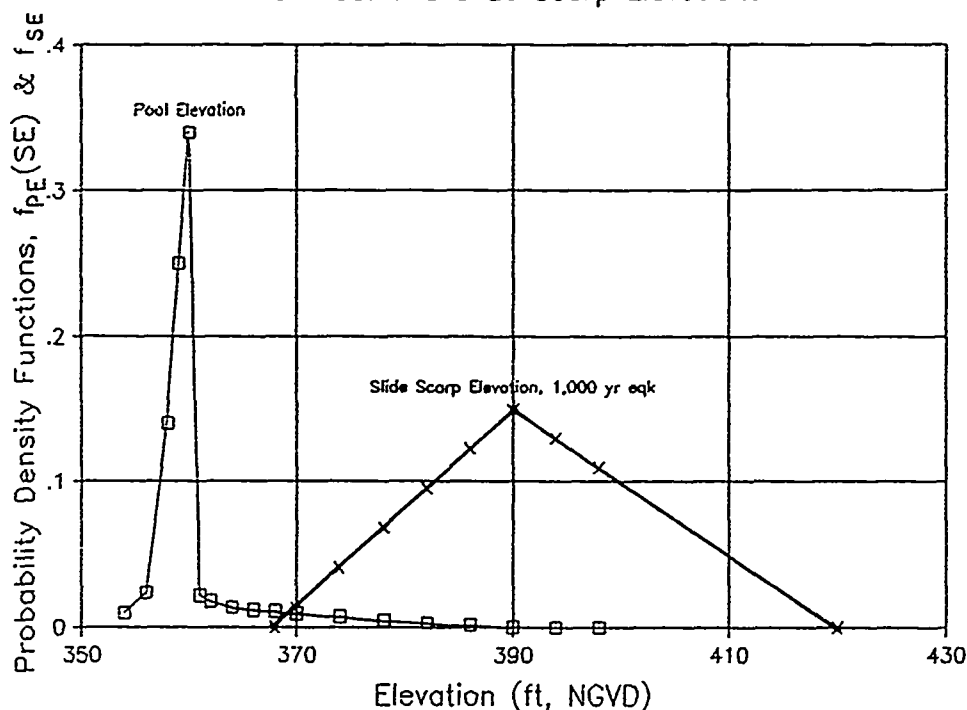
Figure 3. Comparison of Probability Density Functions for Slide Scarp and Pool Elevations.

The density functions for pool elevation,  $f_{PE}(SE)$ , and scarp elevation for the 1,000 year event,  $f_{SE}$ , are compared in Figure 3. The

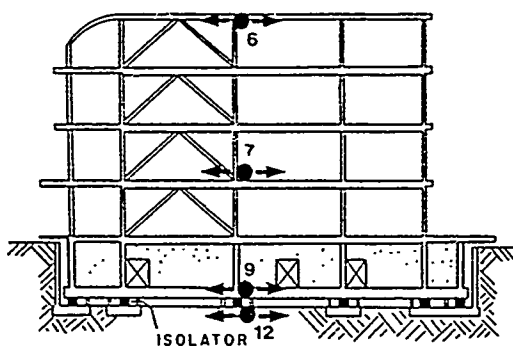
Figure 4. Cross Section of the Minor Axis of the FCLJC and Locations of Accelerometers Nos. 6, 7, 9, and 12.

The State of California Office of Strong Motion Studies has instrumented the FCLJC building with a total of 19 accelerometers as part of the California Strong Motion Instrumentation Program (Huang et al, 1986). Figure 4 shows a cross section through the center of the FCLJC building; also shown are the locations of four of the accelerometers which are oriented to record motions parallel to the minor axis of the building. Accelerometer No. 6 is located on the roof of the building, Accelerometer No. 7 is mounted on the second floor, Accelerometer No. 9 is located at the basement level (above the isolators), and Accelerometer No. 12 is mounted at the

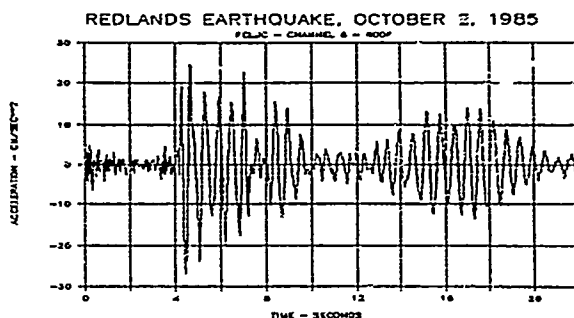
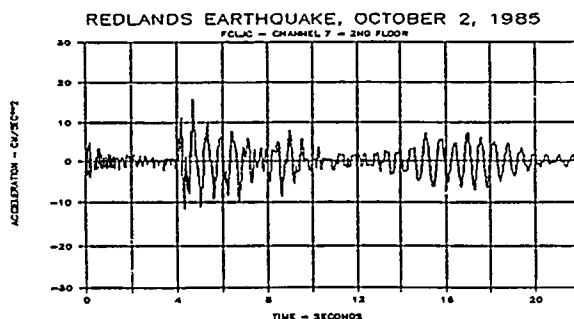
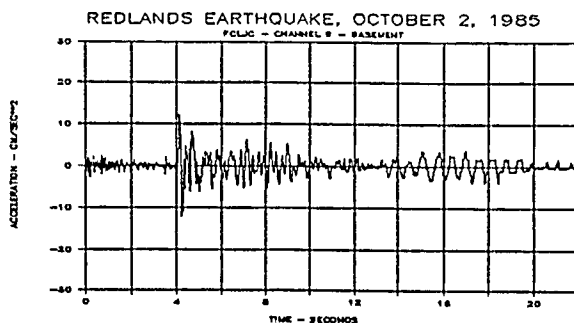
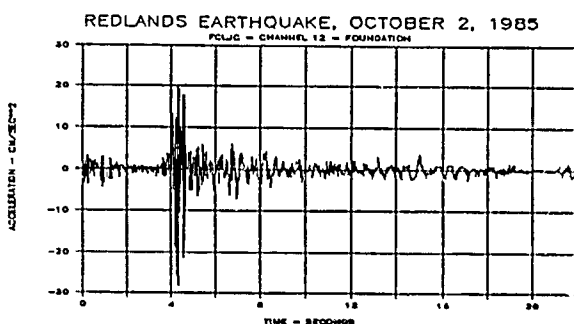
Figure 5. Acceleration-Time Histories Recorded During the Redlands earthquake of October 2, 1985.

Although only recently completed, ground and building motions caused by several small earthquakes have been recorded at the FCLJC building. The processed accelerograms for Accelerometer Nos. 6, 7, 9, and 12 recorded during the Redlands earthquake of October 2, 1985 (magnitude 4.8 ML) are shown in Figure 5; the epicenter of this event was about 30 kilometers from the building. It is obvious from a visual inspection of these four accelerograms that the high frequency horizontal motions present in the foundation recording have been filtered out by the isolators as these frequencies are not present in the records above the isolators; this can be clearly seen in the roof and second floor records and is even evident in the basement record. The maximum acceleration at the roof level was about the same as that recorded at the foundation level. The maximum acceleration levels in the basement and the second floor are less than that at the foundation level.

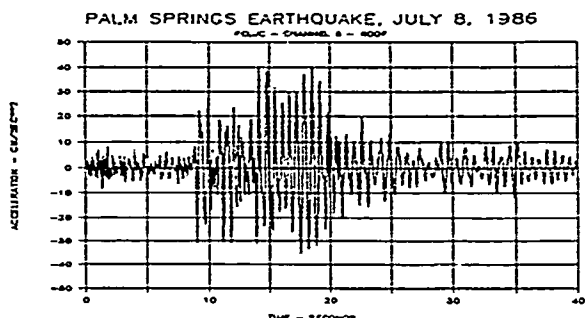
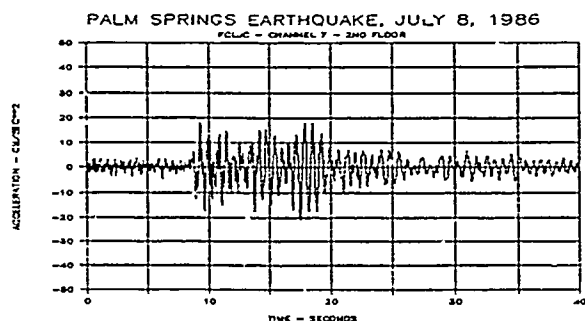
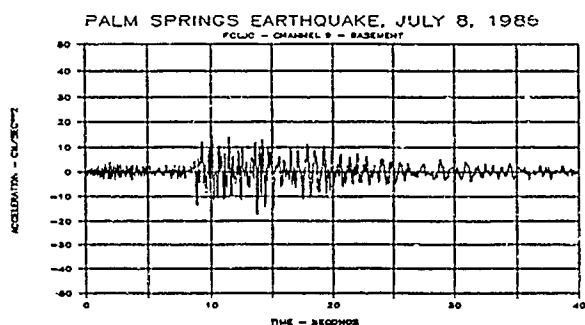
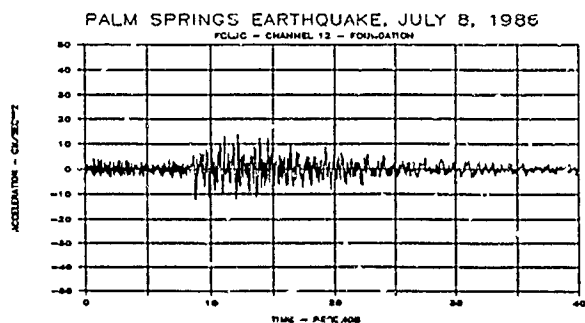
Figure 6. Acceleration-Time Histories Recorded During the Palm Springs earthquake of July 8, 1986.

Processed accelerograms were also available from the Palm Springs earthquake of July 8, 1986 and the records from the same accelerometers are shown in Figure 6; the epicenter of this earthquake was about 100 kilometers from the building. As in the Redlands earthquake, the high frequency waveforms noted in the foundation level record are absent from the other three records. Unlike the Redlands earthquake, there is no reduction in the maximum acceleration level at the basement and there is some amplification of the maximum acceleration at the higher levels; the maximum acceleration at the roof level is about three times the maximum acceleration at the foundation level. Preliminary data from the recent Whittier Narrows earthquake of October 1, 1987 (magnitude 6.1 ML) indicate that a maximum acceleration of about 0.03g was measured at the foundation level and about 0.05g was measured at the roof level (Shakal, 1987); the epicenter was about 55 kilometers from the FCLJC building.

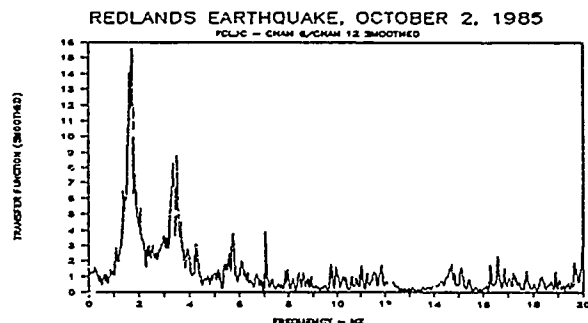
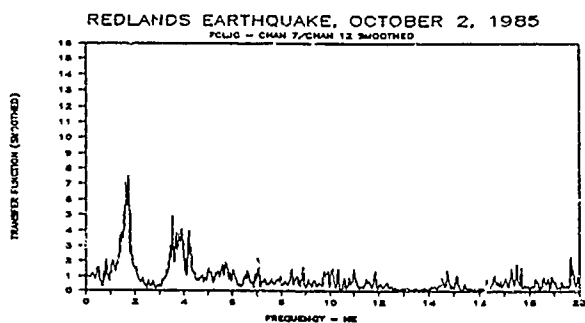
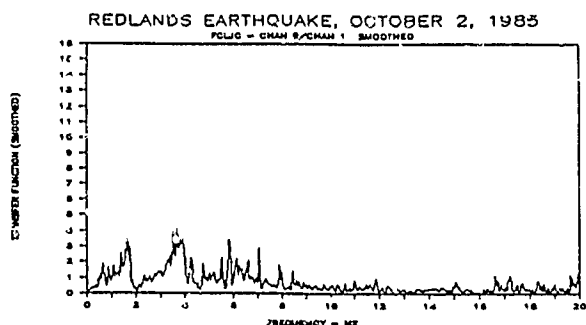
Figure 7. Fourier Transfer Functions - Redlands Earthquake.

Spectral analyses were also performed for these accelerogram records from the two earthquakes. The Fast Fourier Transform (FFT) of each record was computed and smoothed once. Spectral ratios or transfer functions between the three upper building level records and the foundation level record were computed; the transfer functions are shown in Figures 7 and 8. The transfer functions from both earthquake events are very similar. High frequencies above about 10 Hertz are greatly deamplified above the isolators in the building. The fundamental

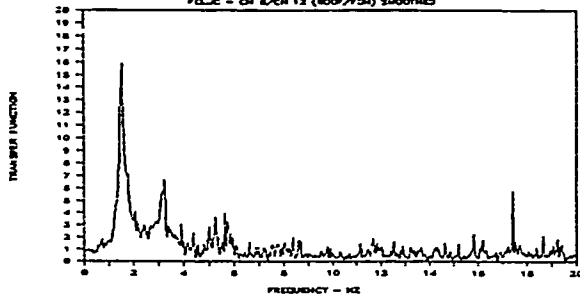
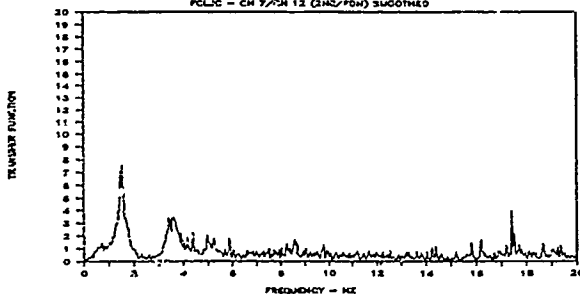
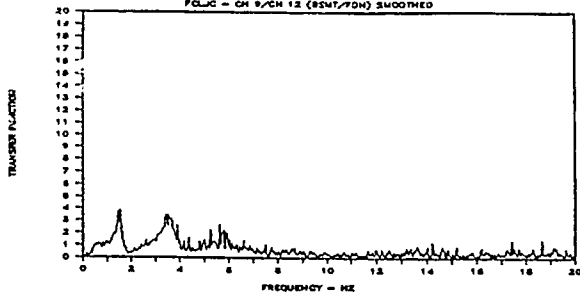
Figure 8. Fourier Transfer Functions - Palm Springs Earthquake.

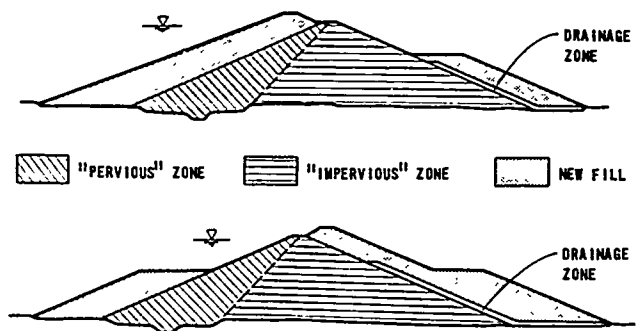
Fig. 2. Selected Design Concepts

The first scheme consisted of upstream and downstream buttresses, similar to modification alternative 5 above, with the objective of improving the dynamic stability of both the upstream and downstream slopes. Additional freeboard was also be provided to compensate

for crest slumping, and a drainage zone was included between the existing downstream face and the new buttress to intercept seepage. The first scheme assumed no excavation and replacement of the existing upstream "impervious" zone. However, two optional sub-schemes were also evaluated: one involving partial excavation and replacement of existing upstream "impervious" material with lower density, new fill to reduce the shear moduli and thus improve the seismic resistance of the materials; and another utilizing high strength rockfill in the upstream berm to improve the seismic resistance of that slope.

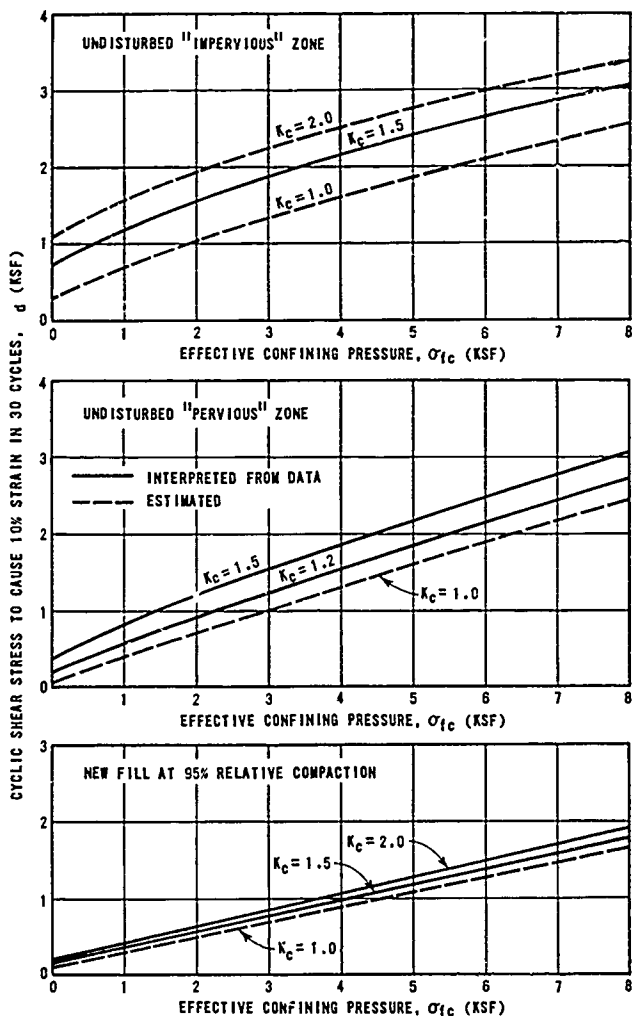
Fig. 3. Cyclic Shear Strengths

and new fill materials, plotted in terms of shear stress on the failure plane at failure vs. normal stress on the failure plane during consolidated.

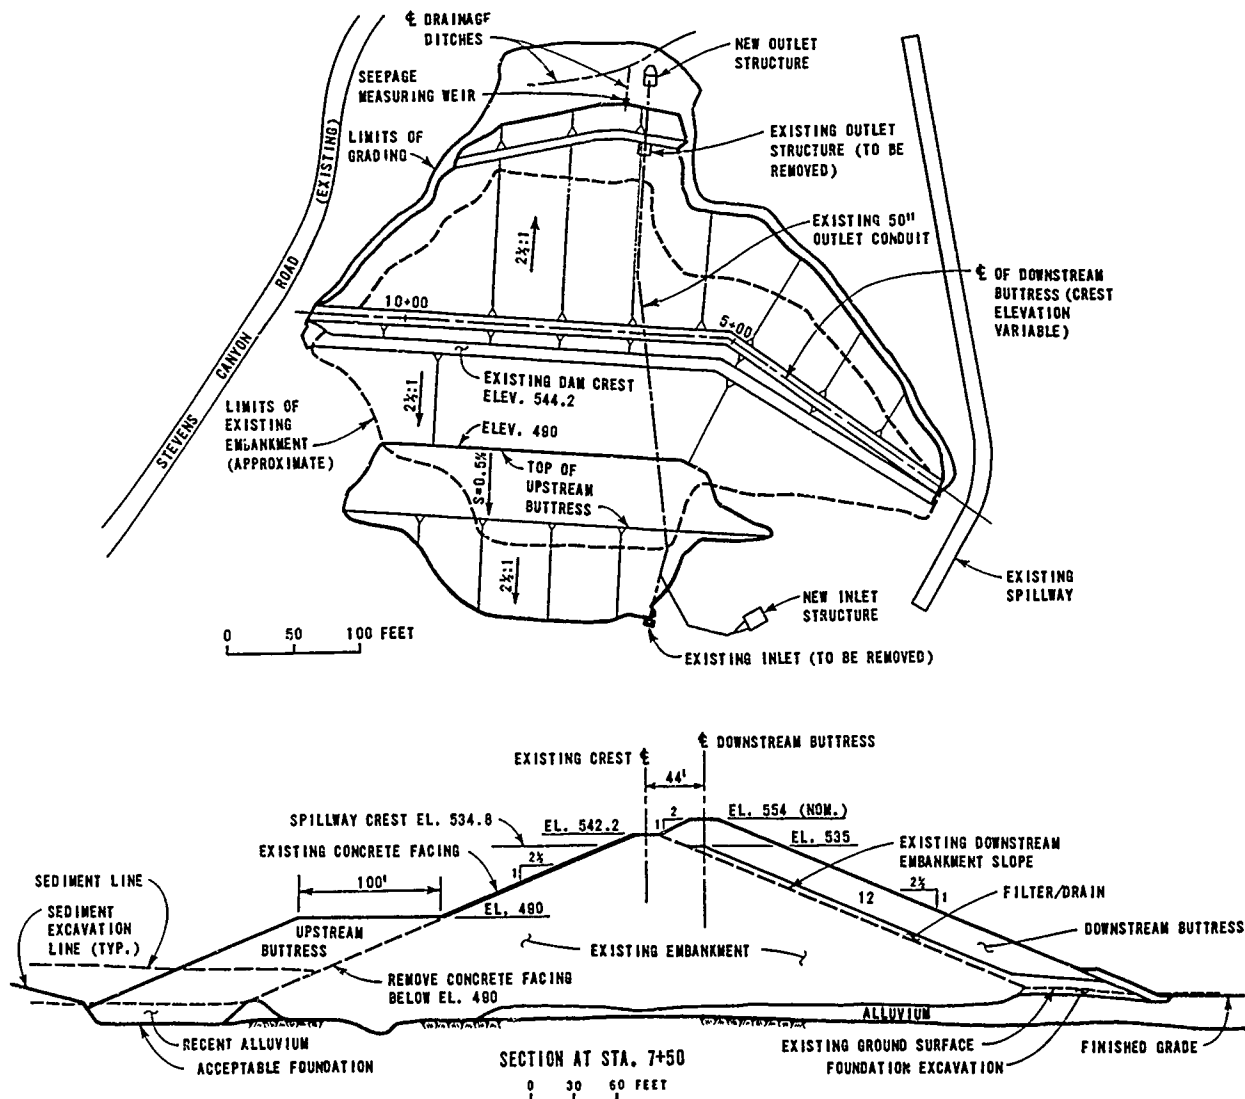
Fig. 4. Plan and Section of Modified Dam

A plan and section of the final design, as constructed, are shown on Figure 4. The dam section, as designed, was essentially the same as was analyzed, except that the bench at Elevation 490 on the downstream face was

deleted from the final design because it did little to improve the seismic performance of the dam. A 12-foot-thick, inclined chimney drain was incorporated at the interface of the existing downstream embankment face and overlying buttress, to prevent saturation of the buttress and to serve as a crack-stopping zone. The base of the chimney drain is in contact with a blanket drain in the channel, which terminates at an inverted filter at the toe of the dam.

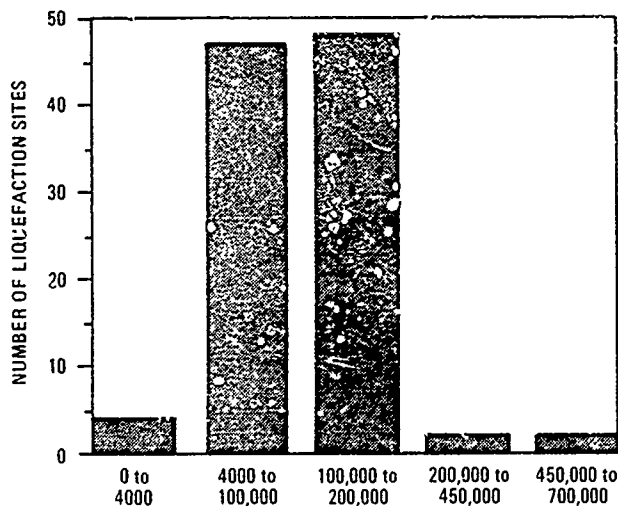
Fig. 1 Breakdown of Liquefaction Sites by Age (yrs).

Based on published information, the age of the host and liquefied materials for each liquefaction site in the Charleston area was estimated. The distribution of liquefaction sites by the age of host materials is presented on Figure 1. As illustrated approximately 90% of the sites occur in materials that were deposited during Late Pleistocene or Holocene times. These deposits correspond to unit Q3 or younger materials as identified by McCarten and others (1984), and the Talbert Formation or younger formations of Coiquihoun (1969). As illustrated on Figure 1, the results of this study suggest that materials older than about 200,000 years appear to be significantly less susceptible to liquefaction than younger deposits. Further, none of the 103 SIL sites identified are located in materials older than about 700,000 years.

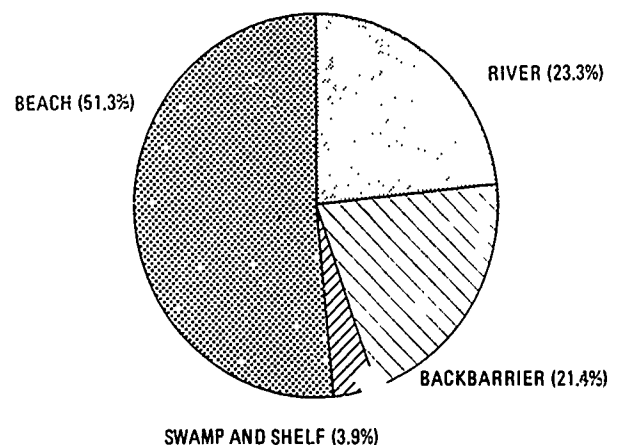
Fig. 2 Breakdown of Liquefaction Sites by Geologic Setting.

Based on published geologic data, field studies, and a geomorphological evaluation, the geologic setting of each of the 103 liquefaction sites was determined. The distribution of liquefaction sites by geologic setting is presented on Figure 2. As shown, virtually all of the liquefaction sites identified in the Charleston, S.C. area are located in one of three general types of geologic setting: 1) beach. 2) backbarrier, or 3) fluvial. As illustrated, approximately half of the sites occur in beach deposits. Most of the remaining sites are located in either back barrier (lagoonal) or fluvial (river) deposits. Very few (less than 4%) occur in other types of depositional environments. As noted by Weems and others (1986) and Obermeier (1986), liquefaction features within beach deposits in the Charleston area are most commonly found along the crests of Upper Pleistocene barrier island complexes.

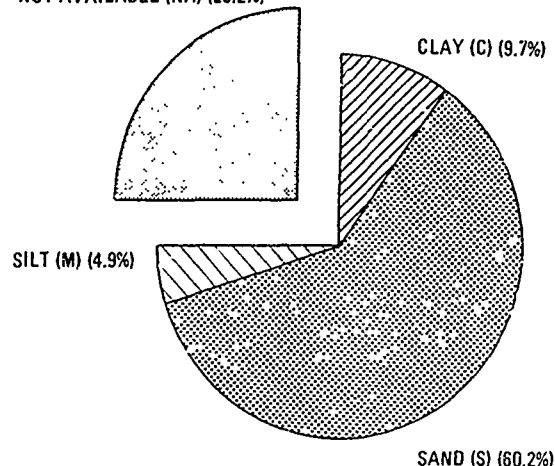
Fig. 3 Breakdown of Liquefaction Sites by USCS Soil Type.

Soil maps were available for about 75% of the 103 SIL sites. Each of these sites were located on these maps and the host soil type was noted. As illustrated in Figure 3, over 60% of the SIL sites are located in soils that are described as sands or silty sands under the Unified Soil Classification System. If percentages are normalized to include only those sites for which soil information is available, almost 90% of the SIL features are located in sands or silty sands.

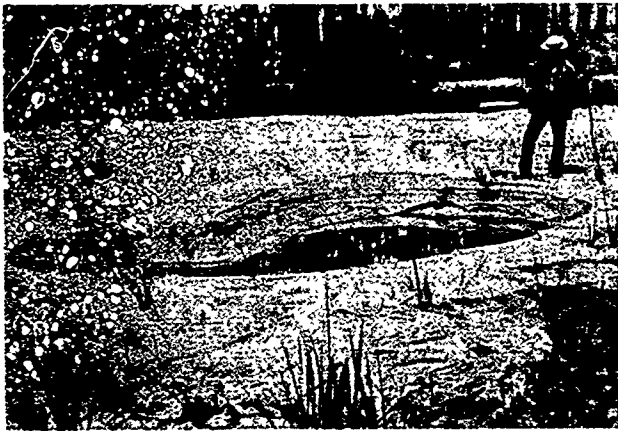
Fig. 4 Sand-Blow Explosion Crater associated with 1886 Earthquake (from Dutton, 1889).

By far the most spectacular liquefaction features associated with the 1886 earthquake were sand-blow explosion craters. An example of this type of feature is shown in Figure 4. As described by Dutton (1889), typical sand-blow explosion craters associated with the 1886 earthquake were about 0.5 to 1.5 meters deep and 3 to 6 meters across. The largest craters reported were approximately 8 meters in diameter. An extensive ejection blanket of sand (up to 0.7 meters thick) extended for tens of

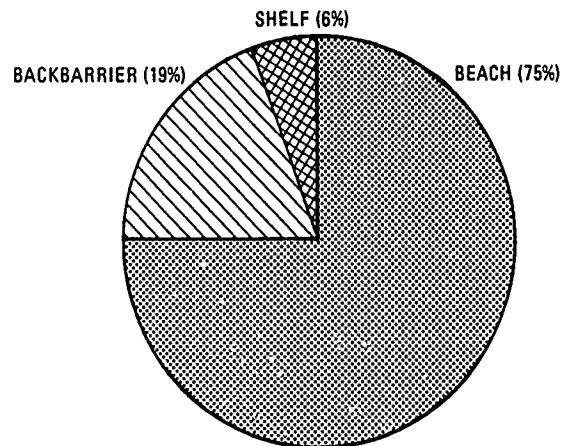
Fig. 6 Geologic Setting of Sand-Blow Explosion Craters.

As illustrated in Figure 6, sand-blow explosion craters are found primarily in beach deposits, and are notably absent in fluvial settings.

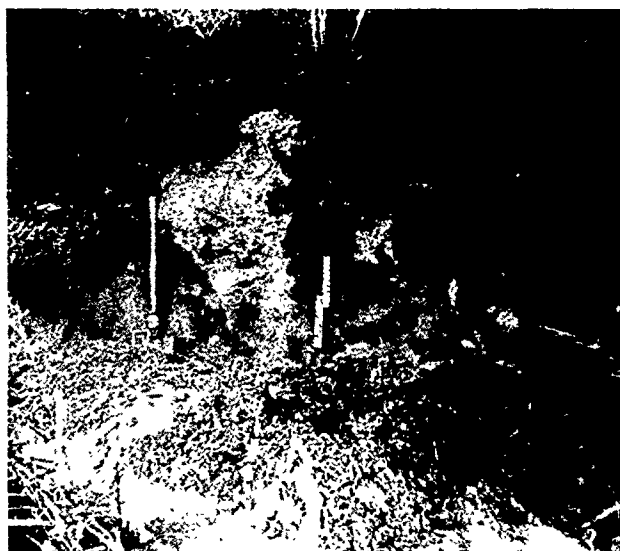
Fig. 8 Example of Sand-Vent/Fissure

At almost all locales where sand-vents/fissures have been found and excavated by 20th century investigators, a non-liquefiable confining layer or "cap" is present over the source bed of liquefied sands. At many sites the cap appears to have been transported short distances down slope due to a decrease in the friction along the boundary between the cap and the underlying sand, consistent with a lateral spreading model for formation. During transport, the cap apparently fails under laterally directed tension, resulting in the ejection of the underlying liquefied sands into the resulting tabular vent in the cap materials. The long axis of the sand-vents/fissures at these sites are generally oriented normal to the direction of lateral transport. Examples of this type of liquefaction feature are presented Figures 8, 9, and 10. When clasts occur within these vents,

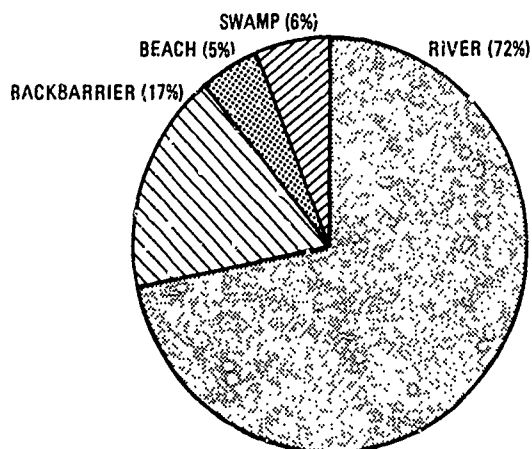
Fig. 13 Geologic Setting of Sand-Vent/Fissures

Sand-vents/fissures are noted to occur almost exclusively where a confining unit lies above liquefiable sands. As illustrated in Figure 13, in the Charleston area this local stratigraphy is most commonly found within backbarrier marine sediments and in interbedded river terrace
